THE METALOCK INTERNATIONAL ASSOCIATION NEWS 2011

**BRAZIL** PAGE 2-3  
*Repair to Ships Wartsila Engine*

**STEP BY STEP** PAGE 4-5  
*The Metalock Process*

**CHINA** PAGE 6  
*Repair to Main Engine Flywheel*

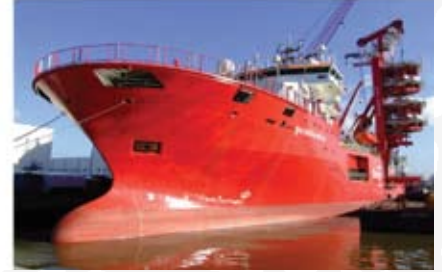
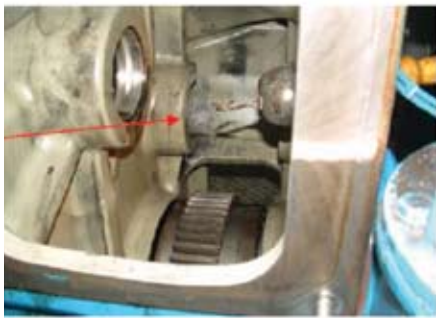
Gears removed exposing the damaged Housing.

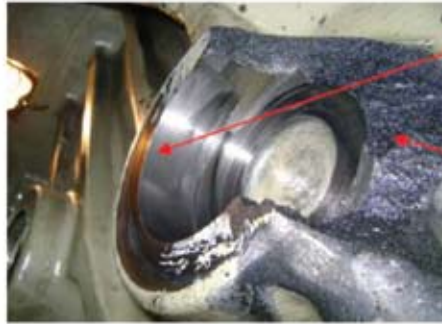
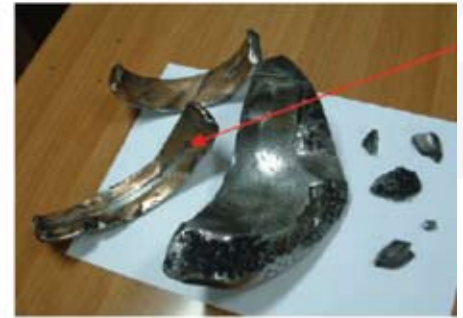
Broken Sections.

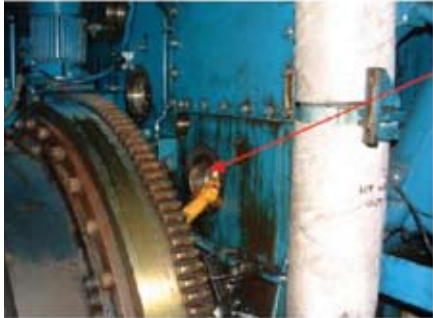
The Flywheel was removed to enable two sections of the Engine to be cut out to access the damaged Housing.

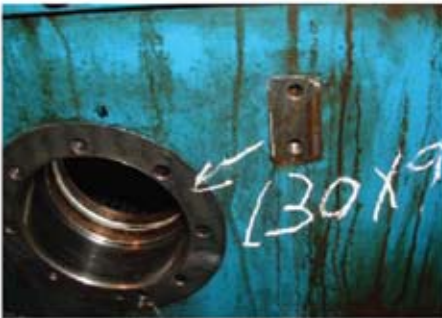
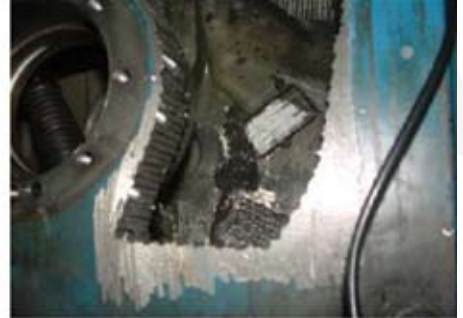
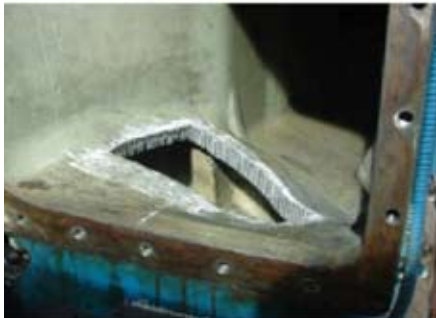
The removed castings taken from the two apertures were retained for use upon completion of the repaired Housing.

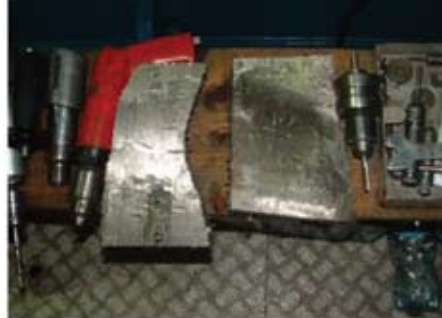
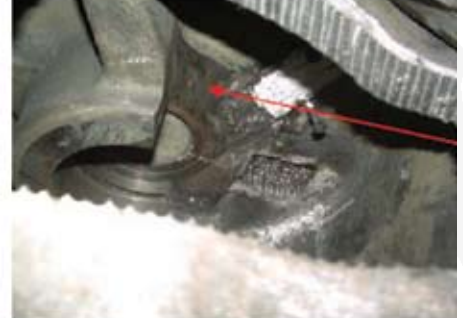
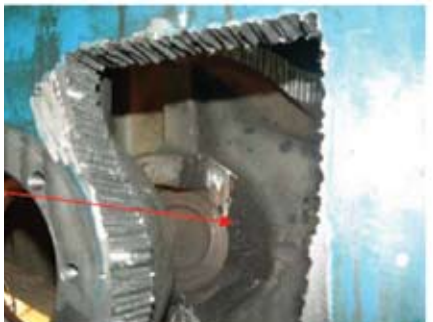
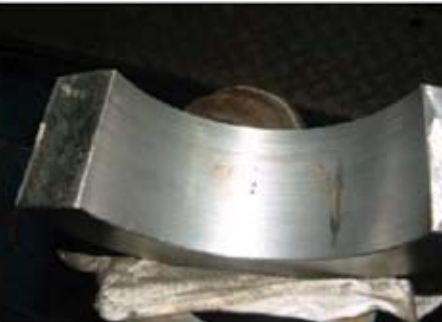
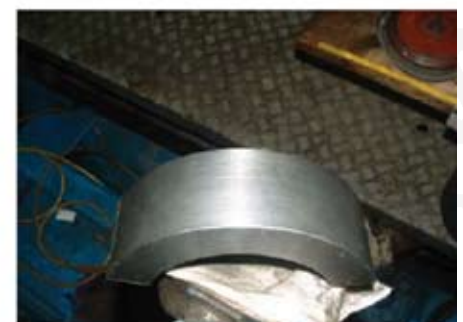
The damaged Housing was prepared to accept the new pre machined insert.

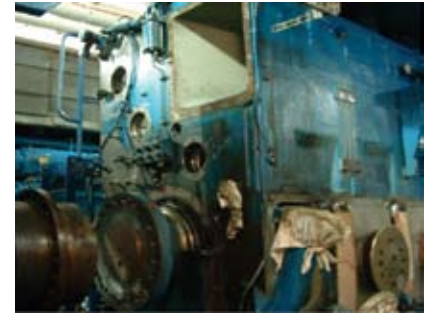
The No.1 Main Engine.

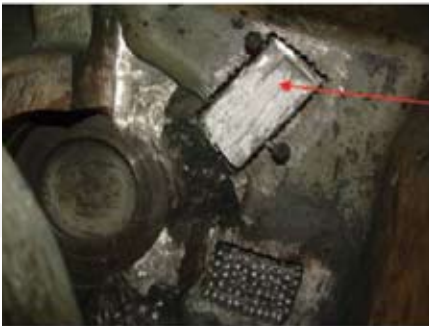
Steel inserts were inlaid into the casing, becoming integral with the parent casting.

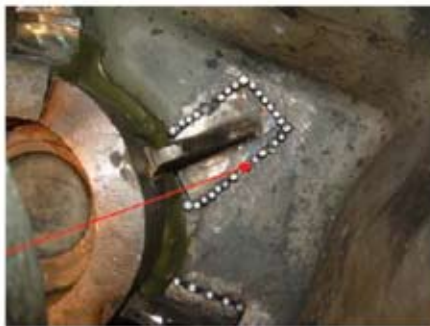
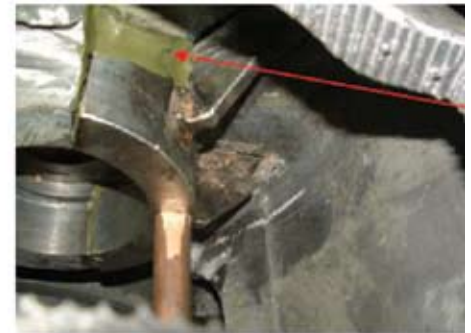
Insert in position with steel brackets.

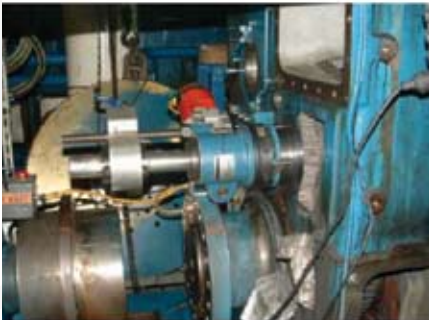
Mounted portable boring bar for machining outer collar of insert and boss material.

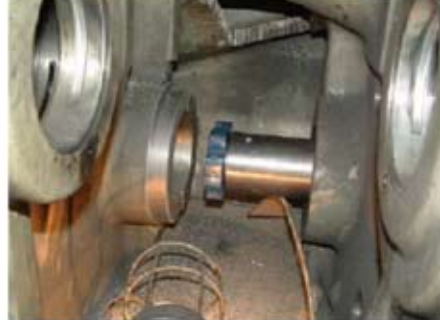
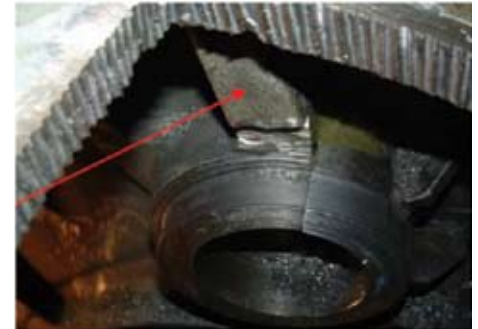
The fitted Inserts O/D has been machined.

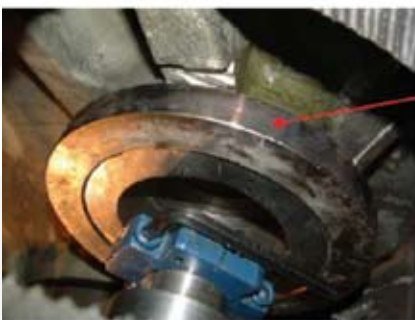
Steel Ring fitted prior to machining.

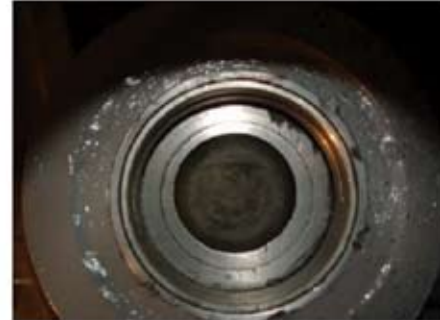
I/D Bush in Position.

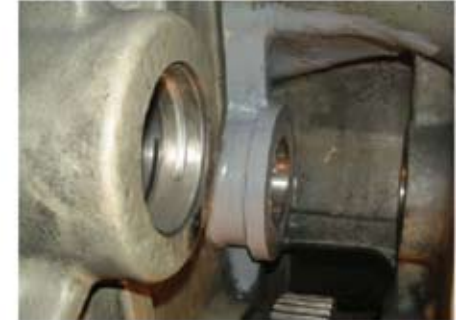
Internal repair completed.

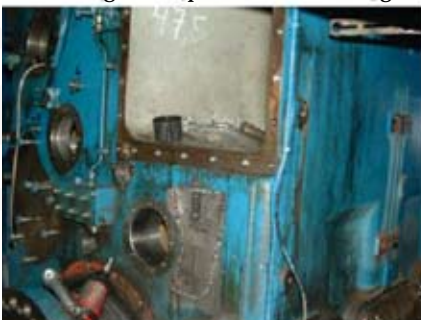
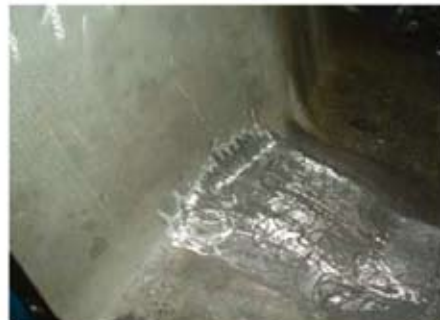
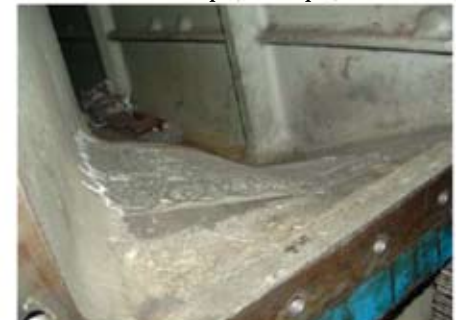
Access apertures closed and secured by the Metallock process and dressed to complete the repairs.

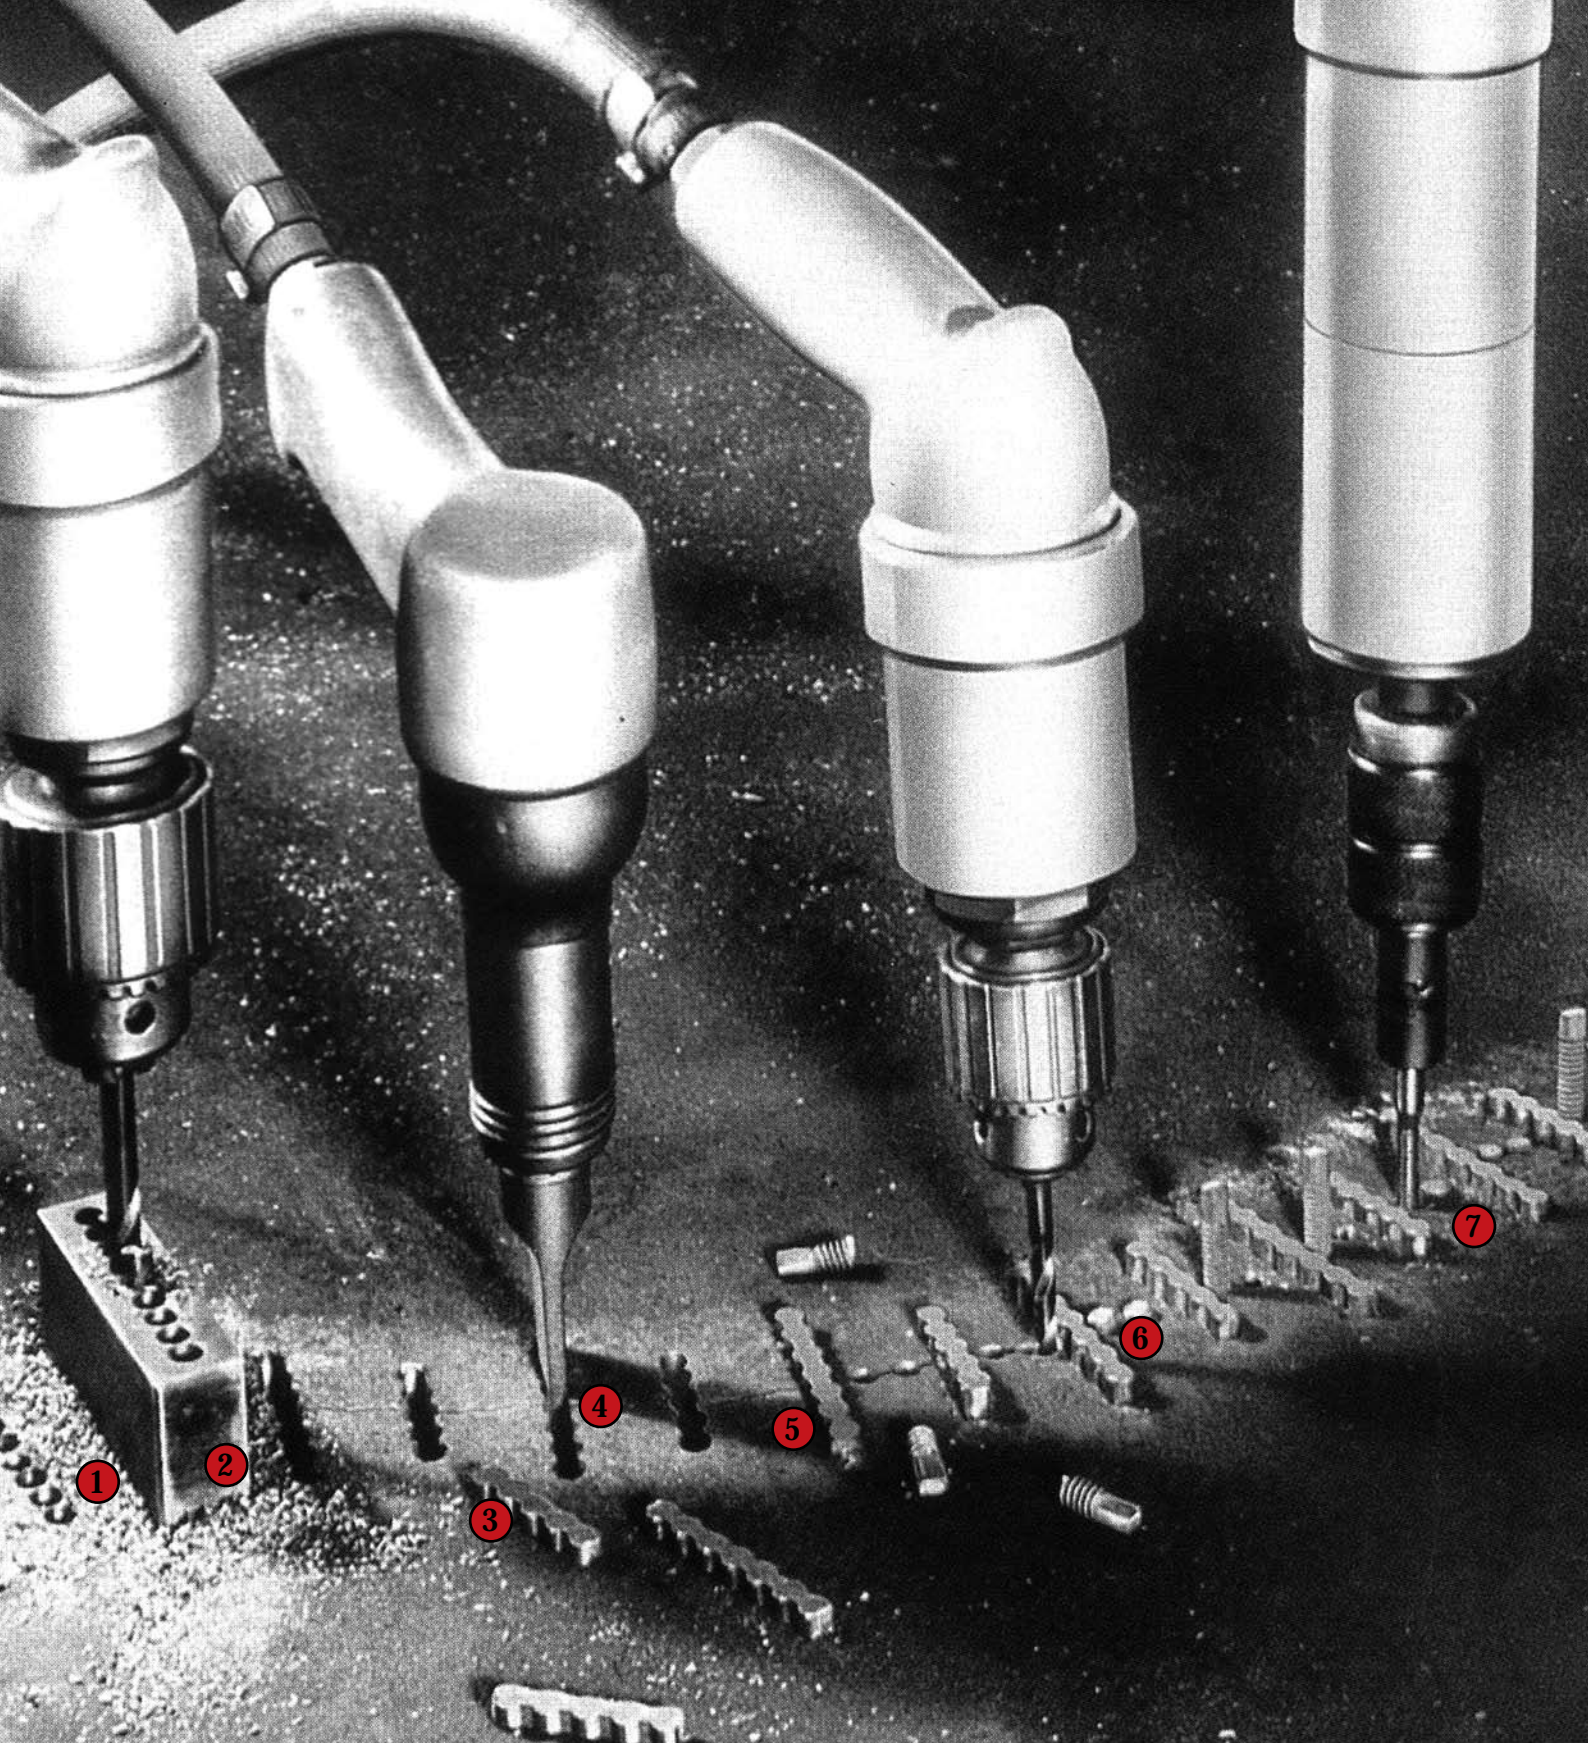
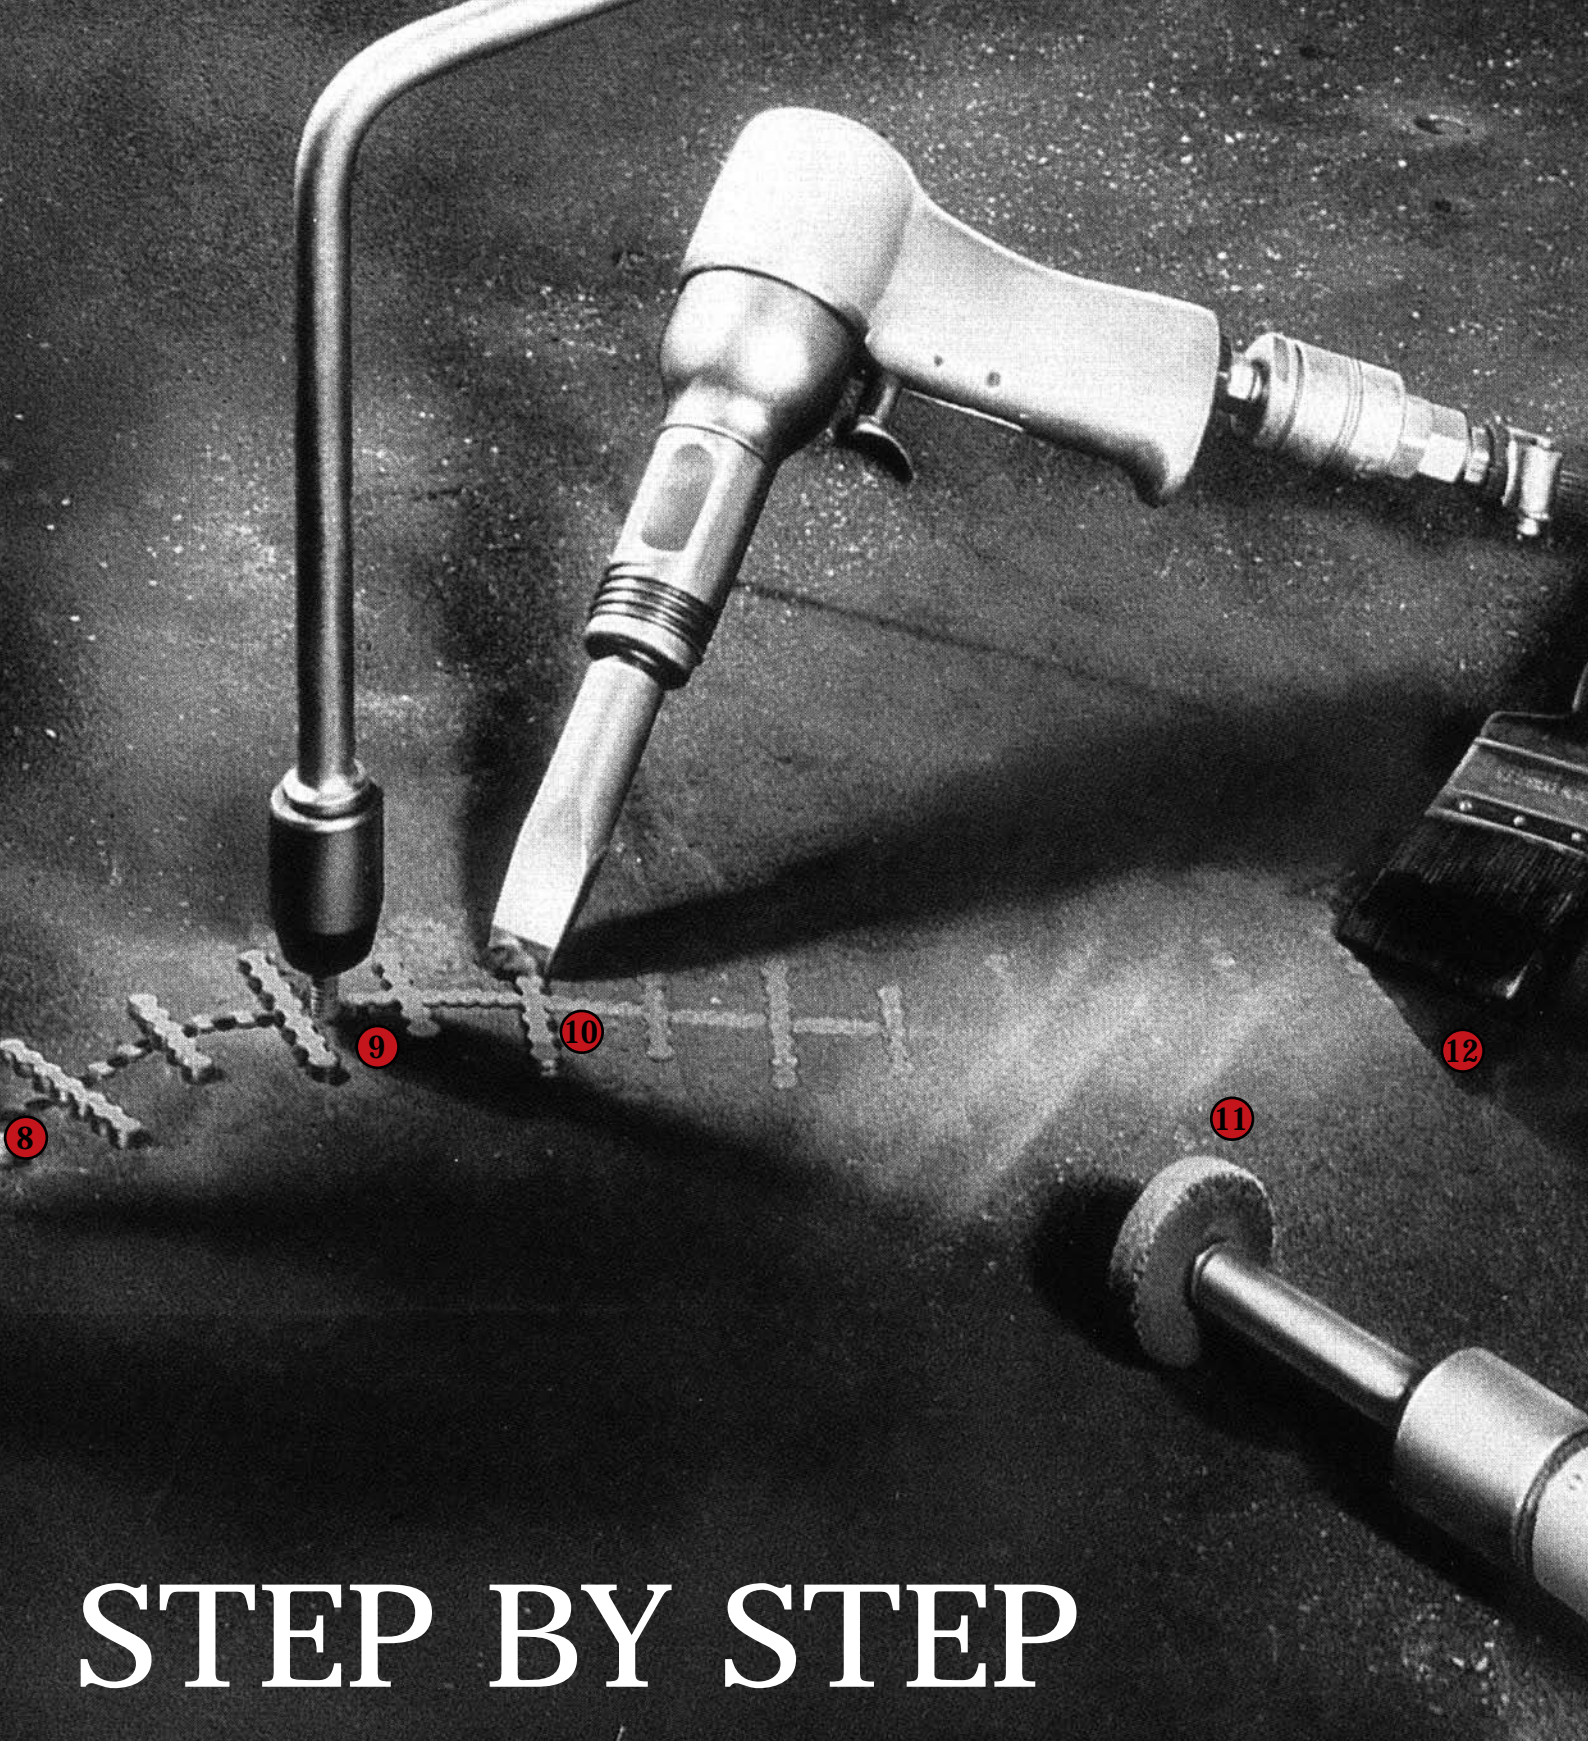
- (1) The fracture, after a survey and report has been presented to the customer, is positioned, realigned, and firmly held together by special fixtures and clamps.
- (2) By the use of special Jigs, groups of holes are drilled across the line of fracture to the tool depth of the casting.
- (3) The Metallock Key is a multi-dumbbell shaped section of highly ductile alloy, the size and length being selected to suit the type of fracture.
- (4) The holes are then joined by the use of pneumatic chisels to conform to the shape of the Metallock Keys.
- (5) Individual layers of Keys are inserted in the apertures and peened into a metal-to-metal condition, which becomes almost integral

with the parent metal. (6) Holes are then drilled along the line of the fracture, then tapped (7), and filled with studs (8), each stud biting into its predecessor, resulting in a pressure-tight joint and restoring a rigidity to the casting. (9) A Metallock stud is an important aspect of the Metallock process, bearing in mind that pressure repairs are often required. (10) The studs are then run down till the heads shear, the remaining rough metal being removed by pneumatic chisels. Finally the whole repair receives treatment from hand grinders (11) prior to its final coat of paint (12).

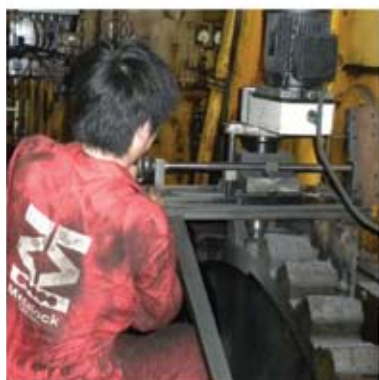
Milling work on the Flywheel.

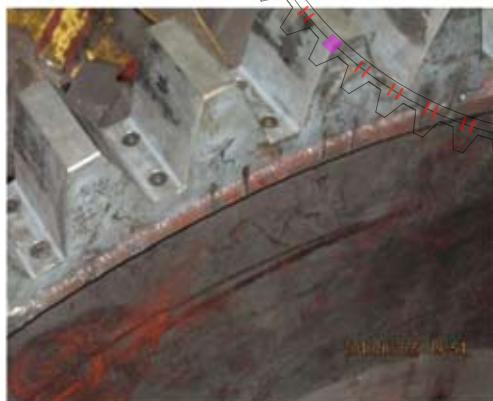
New Teeth Ring secured to the Flywheel with Bolts.

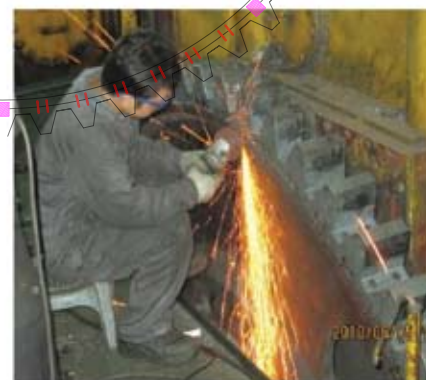
Metallock Teeth Ring to Flywheel.

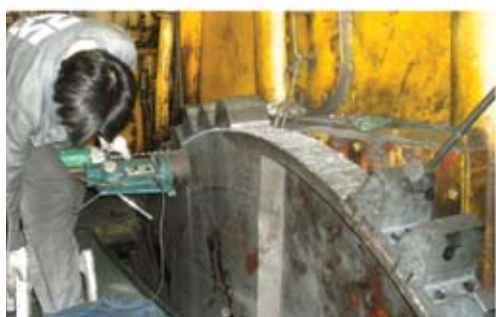
All Teeth were removed by drilling.

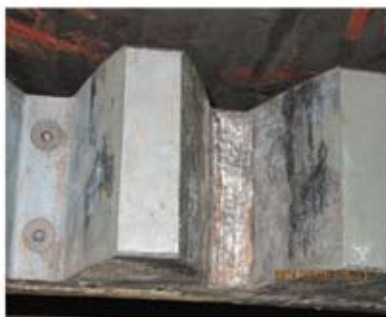
The two joints were welded together.

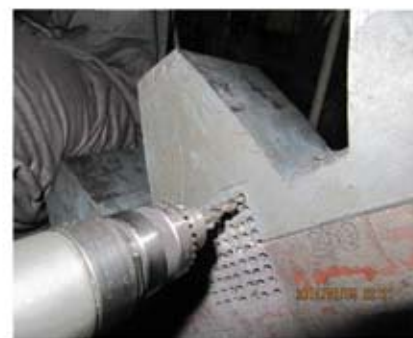
Master Keys were used to strengthen the repair.

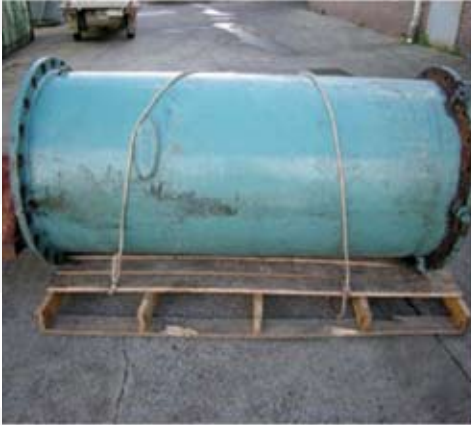
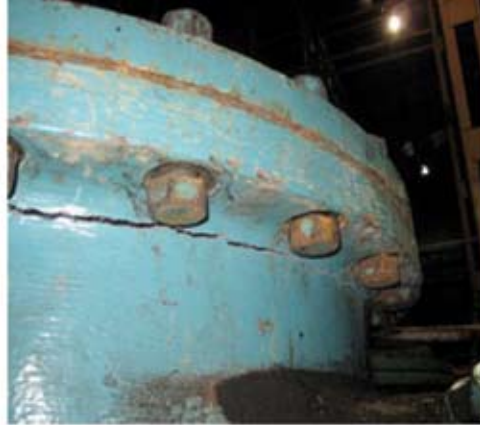
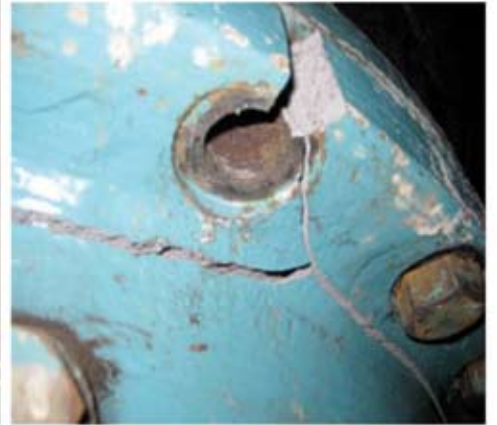
The overall length of the Oil Cooler was 3 metres with a wall thickness of 20mm, the Flange had a diameter of 1050mm. The cracks were on the main body just below the Waterbox Flange. When in service the oil pressure is 100kPa, with an operating temperature of up to 60 deg C.

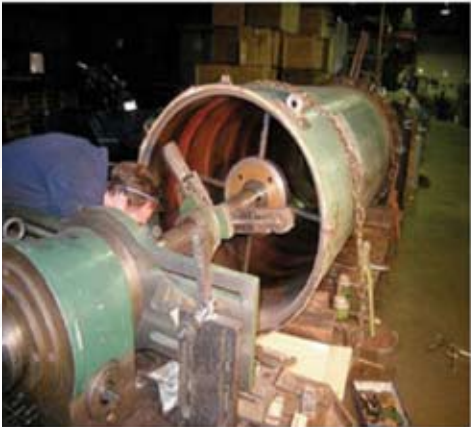
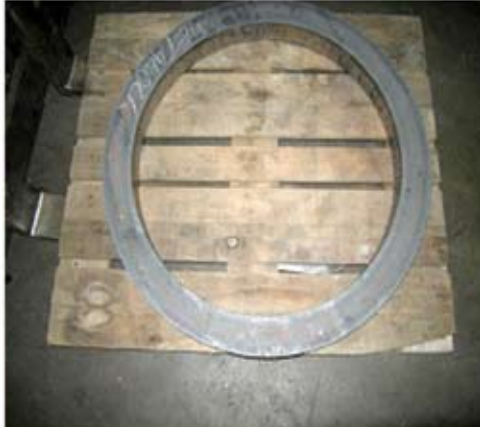
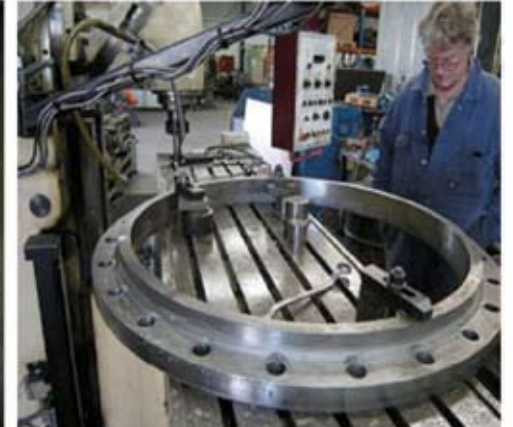
Damage/cracking was extensive requiring a new section to be manufactured and Metalocked into place. The pictures show the damaged Flange being cut off and set up to ensure fitting locations/bolt alignment are maintained.

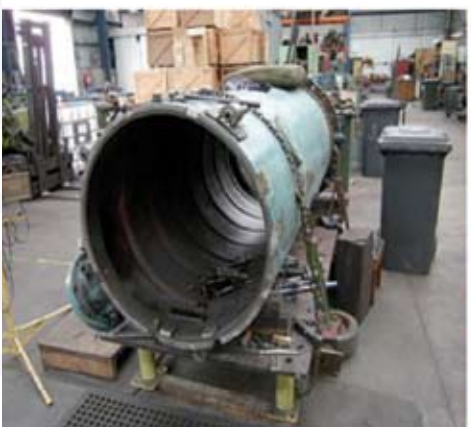
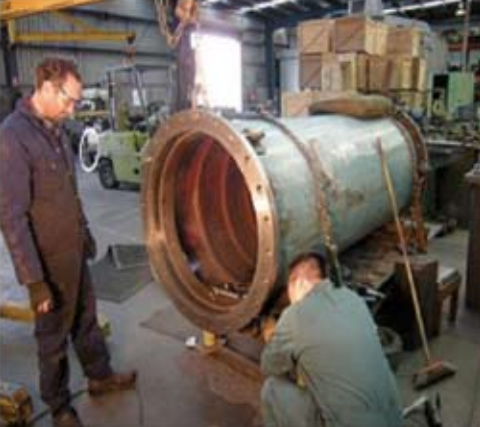
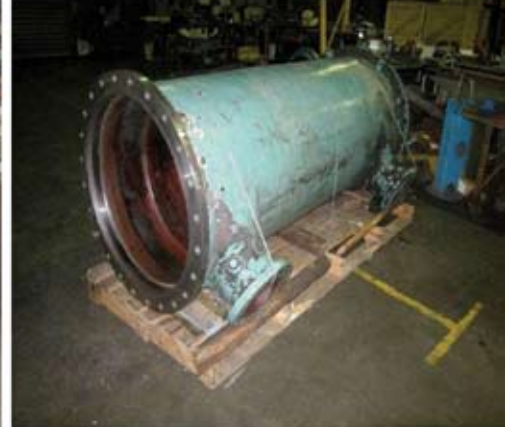
Whilst the body is high grade cast iron, we fitted a steel flange for higher strength and material availability. This is one of the main benefits of Metalock process where dissimilar materials can be co-joined.

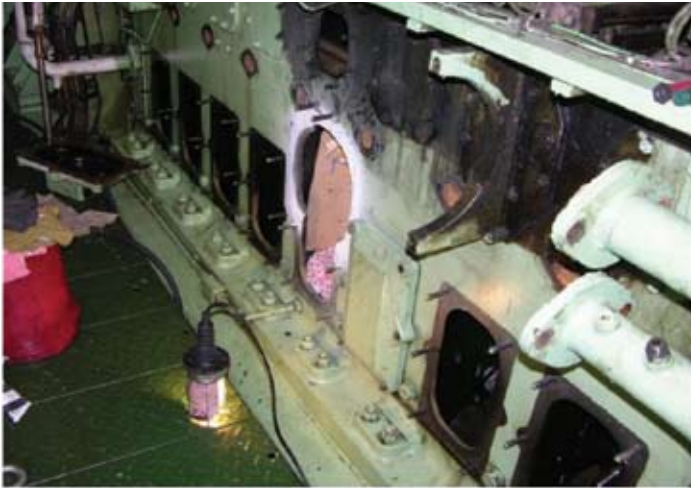
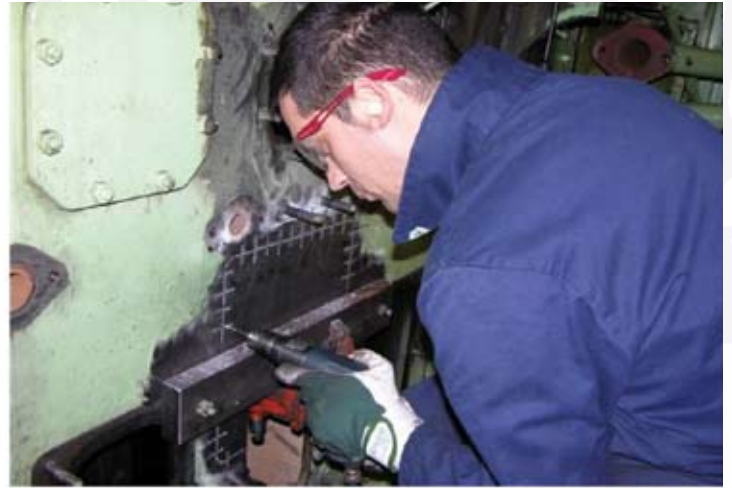
The damage was to an inspection window on one of the generator engines of the vessel.

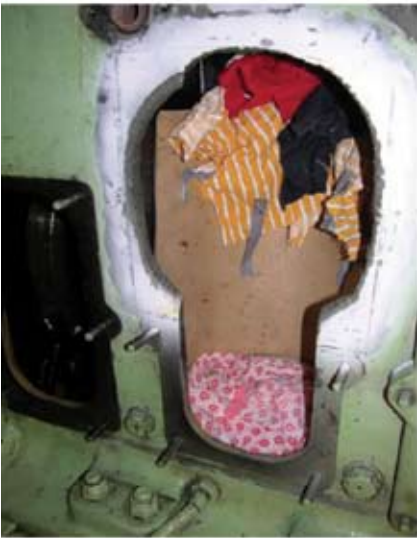
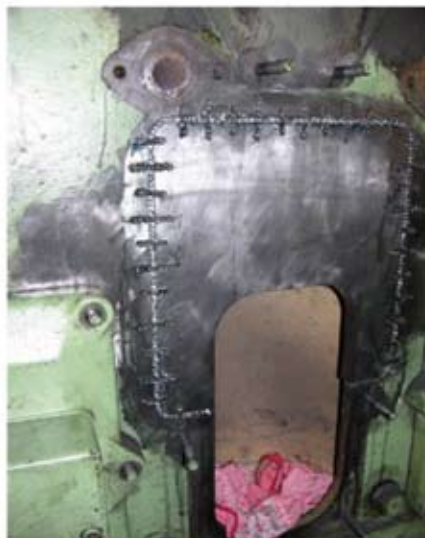
It was necessary to cut away part of the entablature and replace with a new insert made of carbon steel.

The sequence of photos shows the steps of the repair, drilling and cutting out the damaged area, inserting and stitching the new insert.

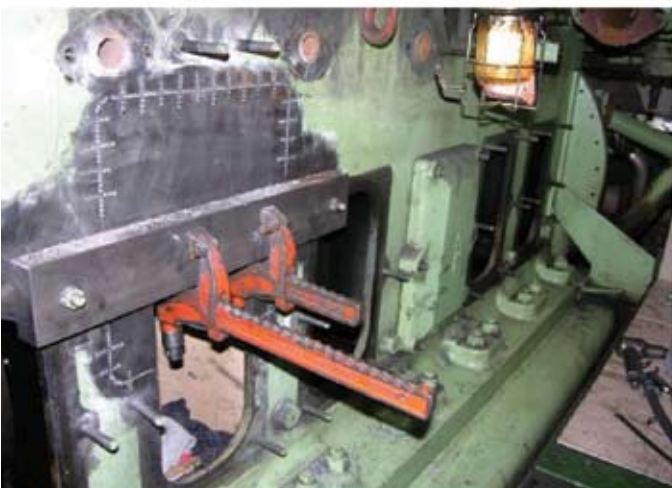
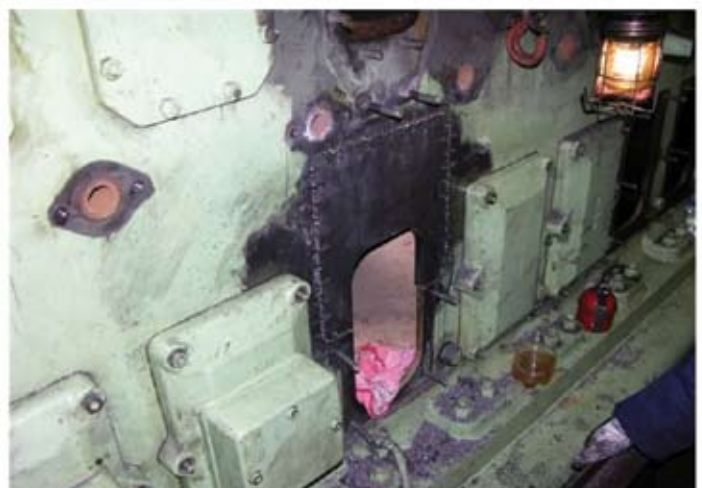
No final machining was necessary as the insert was pre-machined and precisely inserted by the help of a machined anchor plate.
